FIELD REPORT #25

REFERENCE *29 West 15th Street
Façade Restoration*

North Elevation – Progress Inspection + Probe above 8th Floor Window

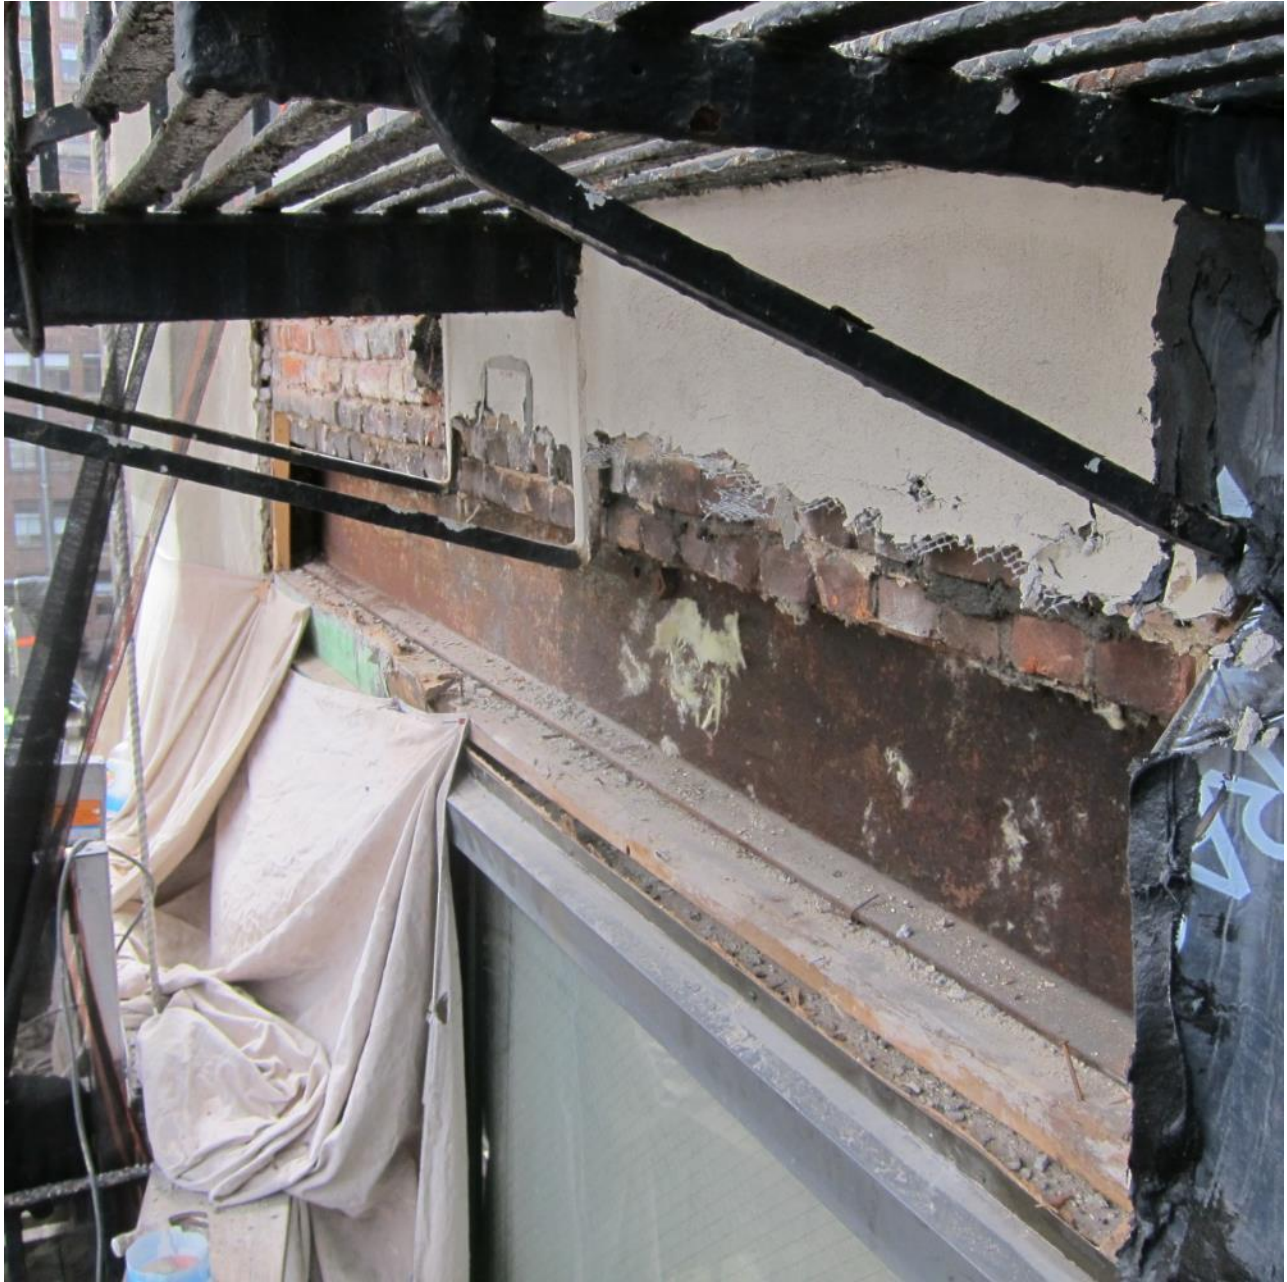
CBR has enlarged the probe above the 8th floor window. AMR was able to access the area and take measurements and observations. The air space above the 8th floor window and the existing building steel mentioned in Field Report #24 spans the entire width of the window.

Photo 1:
General view of the probe opening on the 8th Floor.

- CBR to review the attached detail and provide a price to install as shown on SK-1 attached to this report.
- CBR to submit proposal to AMR for review

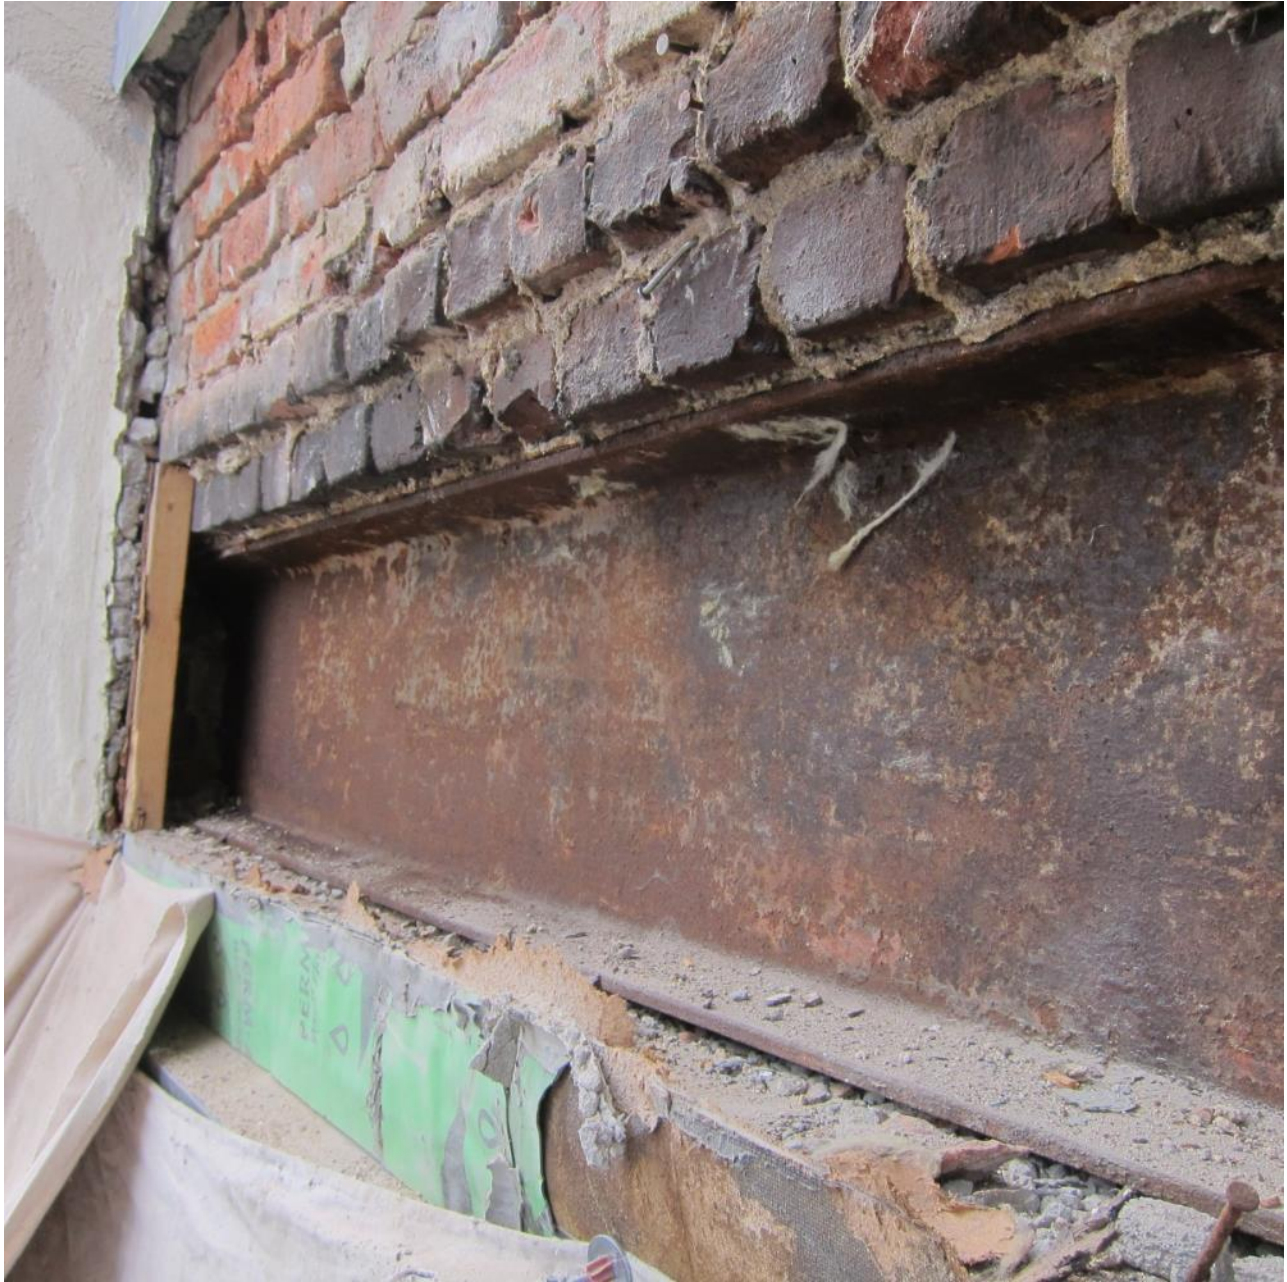
Photo 2:
Close view of the probe opening on the 8th Floor.

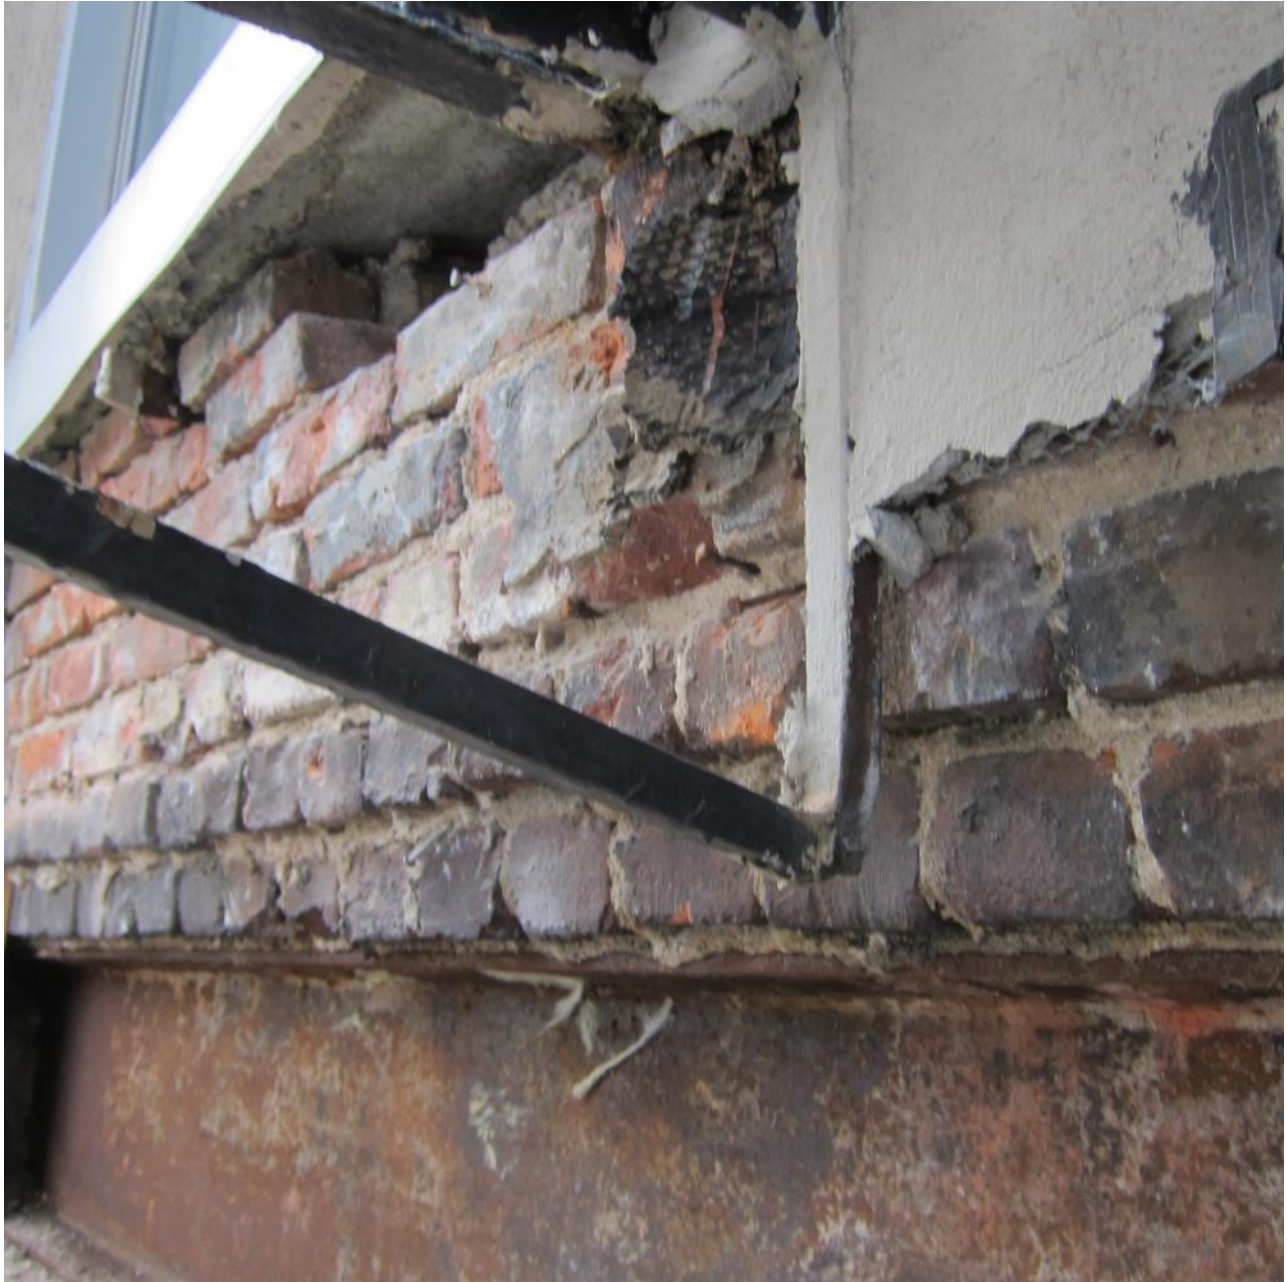
Photo 3:
Close view of the probe opening on the 8th Floor.
