FIELD INSPECTION REPORT

Building: 170 North 11th Street, Brooklyn, NY **Project No.:** 1460 **Report Date:** 10/11/17

Project Description: Limited Exterior Repairs

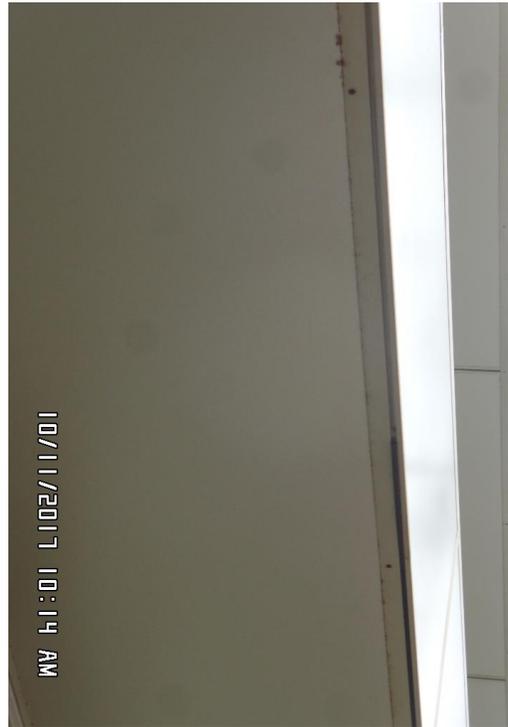
4. At the 6th floor level at the cladding overhang there are some missing black plastic trim pieces from the cladding drip edge. See attached photo #1. CBR have not mobilized to this area or begun work yet. CBR have contacted the cladding manufacturer to obtain replacement pieces but they are not available. CBR propose to install a bead of black Sikaflex sealant in this location to provide a uniform visual appearance from below. This is an acceptable solution in our opinion.

Photo #1 – Missing Black Trim at Cladding Overhang

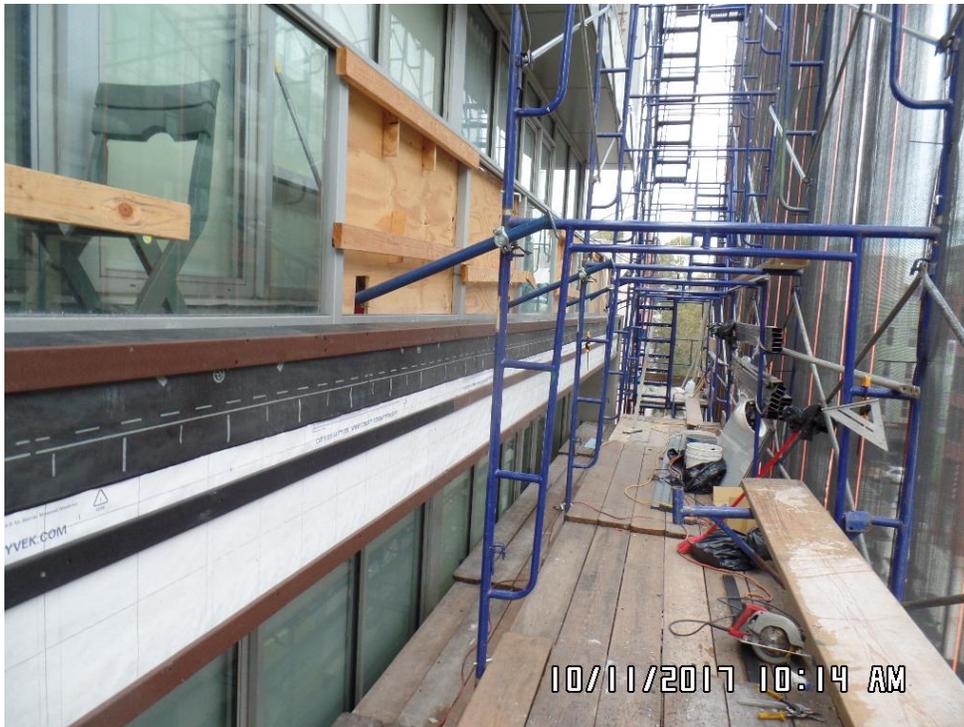
1. CBR has completed waterproofing and cladding reinstallation at the 2nd, 3rd and 4th floor levels.
2. CBR are currently in the process of cladding reinstallation at the 5th floor level.

Photo #2 – 5th Floor Plastic Wood Installation
